Manhole Inspection Summary

Manhole # S33S__009MH

Location Address: **139 w ostend st**

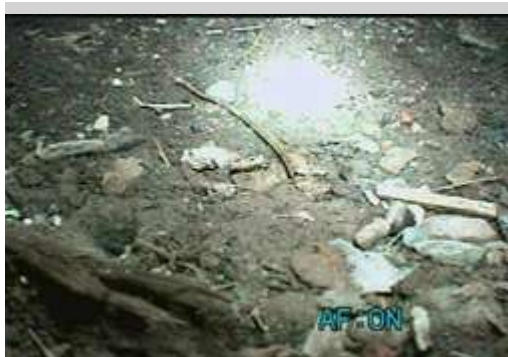
misc. channel debris

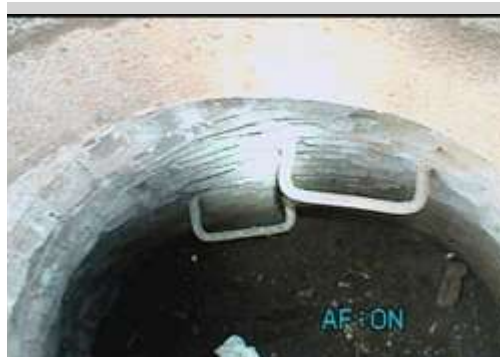
Defect 4

channel debris

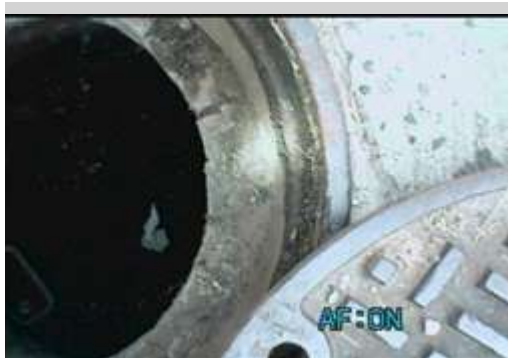
Defect 2

offset

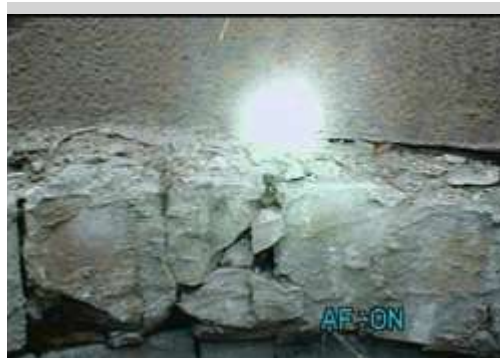
Defect 1

Condition: ☐ Sound ☒ **Cracked** ☐ Root Intrusion ☐ Loose Brick ☒ **Deteriorated**

chimney cracked and deteriorated, frame adj
